NATIONAL REGISTER OF HISTORIC PLACES

Highland Cotton Mills Village Historic District

High Point, Guilford County, GF0636, Listed 05/23/2014

Nomination by Laura A. W. Phillips

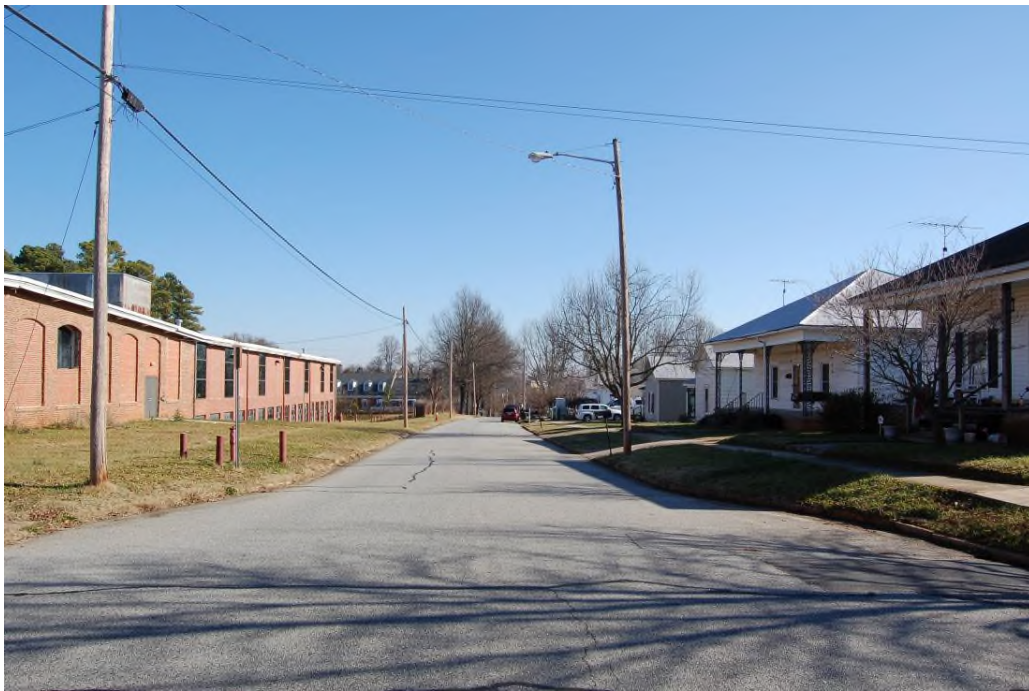
1000 Block of Mill Avenue, looking east

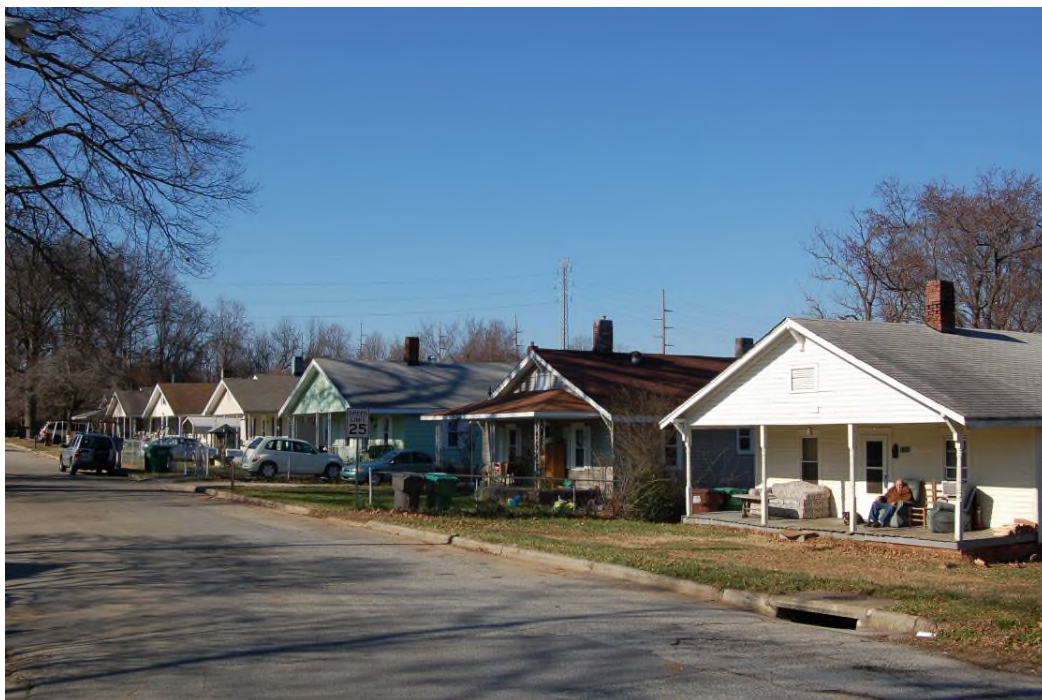
1100 block of Young Place, north side

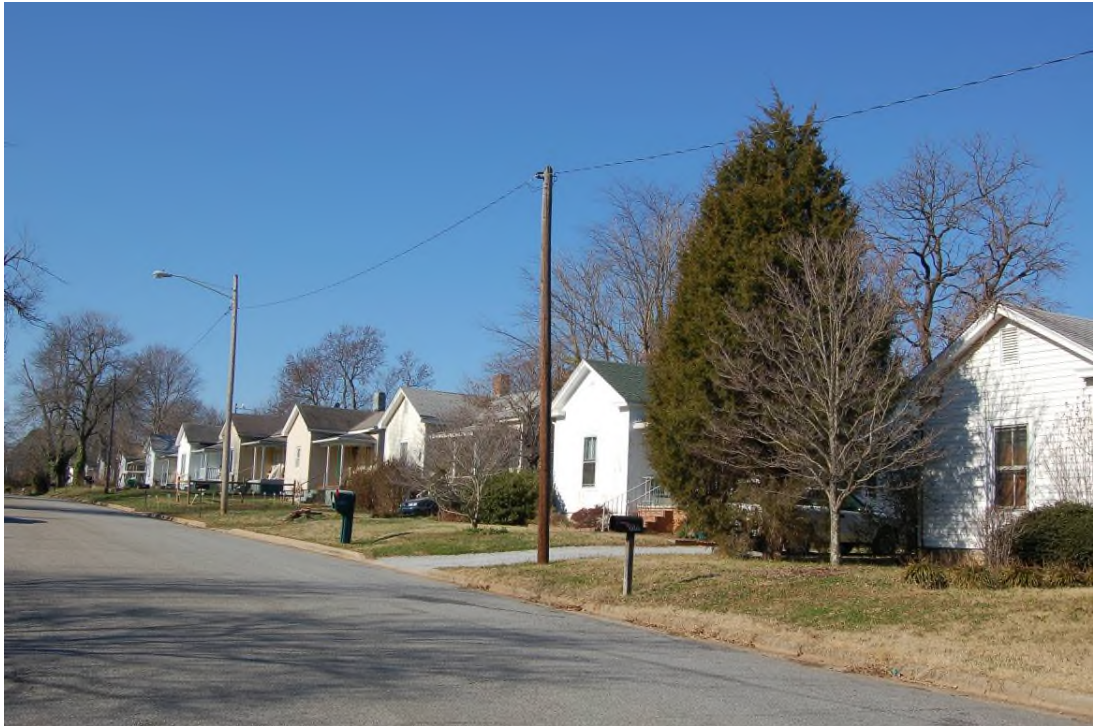
900 and 1000 Blocks of Proctor Drive, north side
