NATIONAL REGISTER OF HISTORIC PLACES

David A. Barnes House

Murfreesboro, Hertford County, HF0031, Listed 06/13/2014

Nomination by Elizabeth Crawley King

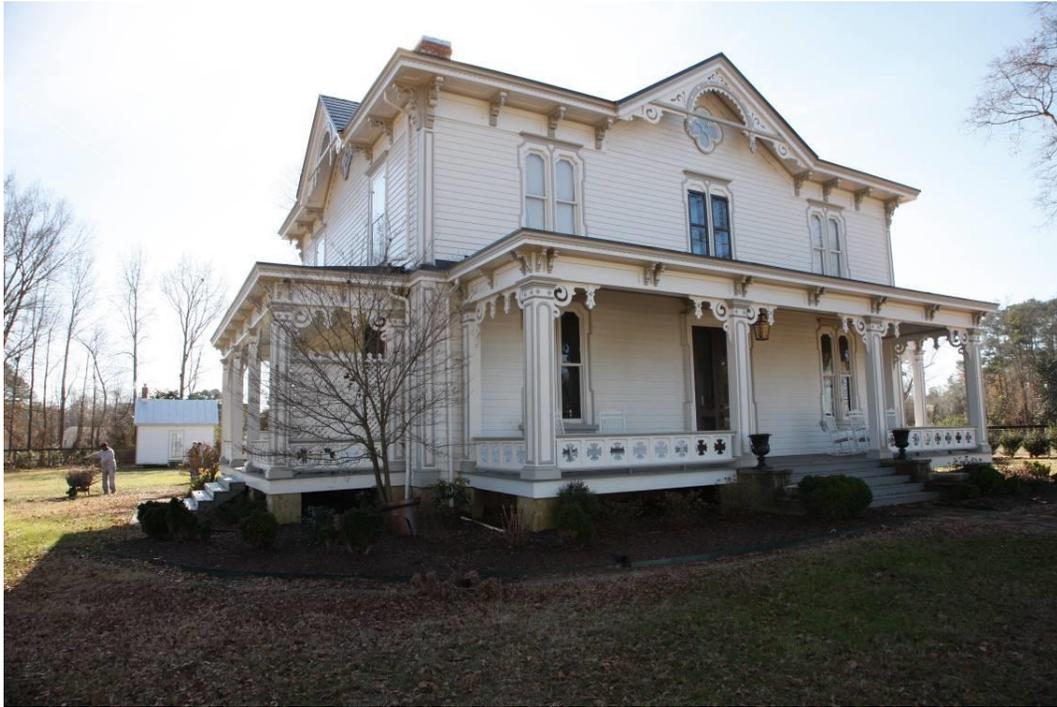
Overall view

Completed in 1875, the David A. Barnes House is a large, two-story, three-bay-wide, hip-roof frame dwelling in the Italianate style. Elaborate eave gables on the front (north), east, and west elevations enliven its conservative rectangular footprint. The building is clad in plain weatherboards. Molded corner boards support a paneled frieze, and brackets with pendants carry the deep overhang of the roof. Decorative horseshoe trusses with jig-sawn trim embellish the eave gables. Quatrefoil windows pierce the gable peaks. Two brick chimneys emerge at the hip break in the roof. The roof was originally clad in wood shingles but is now covered in pressed metal. A one-story, hip-roof porch supported by four square-paneled posts with sawn brackets covers the lower façade, and paired, narrow one-over-one double-hung sash windows flank the double-glazed entry doors. Elongated cutbacks within the door and window surrounds create crossette-like protrusions at the top and bottom of the surrounds. Additional one-story porches are located against the side elevations. The east porch shelters two bays and the west porch shelters a single bay. Large glazed pocket doors slide open onto each side porch. All porches have wood decks and ceilings. Short flights of wood stairs give access to the porches, which are elevated on brick piers. Originally, sawnwork cresting pierced with Greek crosses followed the perimeters of the porch roofs, but this feature is now missing. The east, west, and rear (south) elevations contain single six-over-six double-hung sash windows. On the rear elevation, two one-story, one-bay-wide, shed-roof wings flank an open center bay containing a double-leaf folding door with three-light transom and support a second-floor shed-roof bay. The first-floor shed-roof wings are original to the house; the second-floor shed-roof bay was added to the house around the turn of the twentieth century. A ca. 1950 one-story, flat-roof hyphen connects the west wing to a small, turn-of-the-twentieth-century, gable-roof kitchen placed perpendicular to the hyphen. A new wood deck extends from the rear of the house and along the east elevation of the kitchen. The Barnes House is elevated on a brick pier foundation.

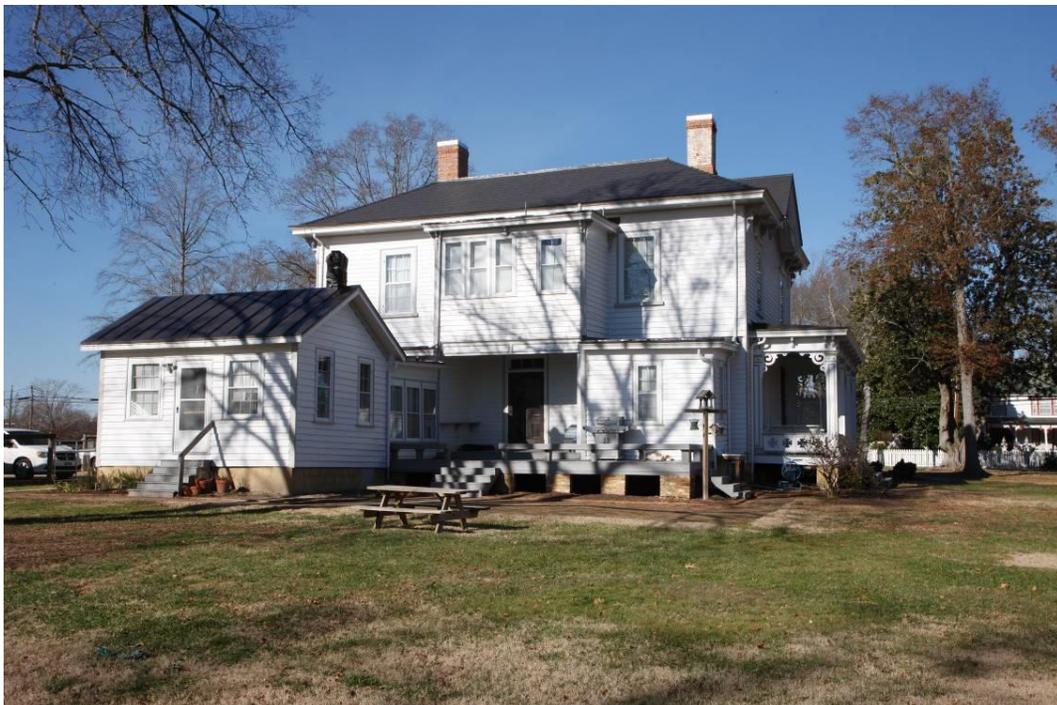
Rear view
