National Register of Historic Places Inventory—Nomination Form

historic Duke-Lawrence House

street & number South side of NC 305/561, 0.6 mi. east of Junction with SR 1521
not for publication

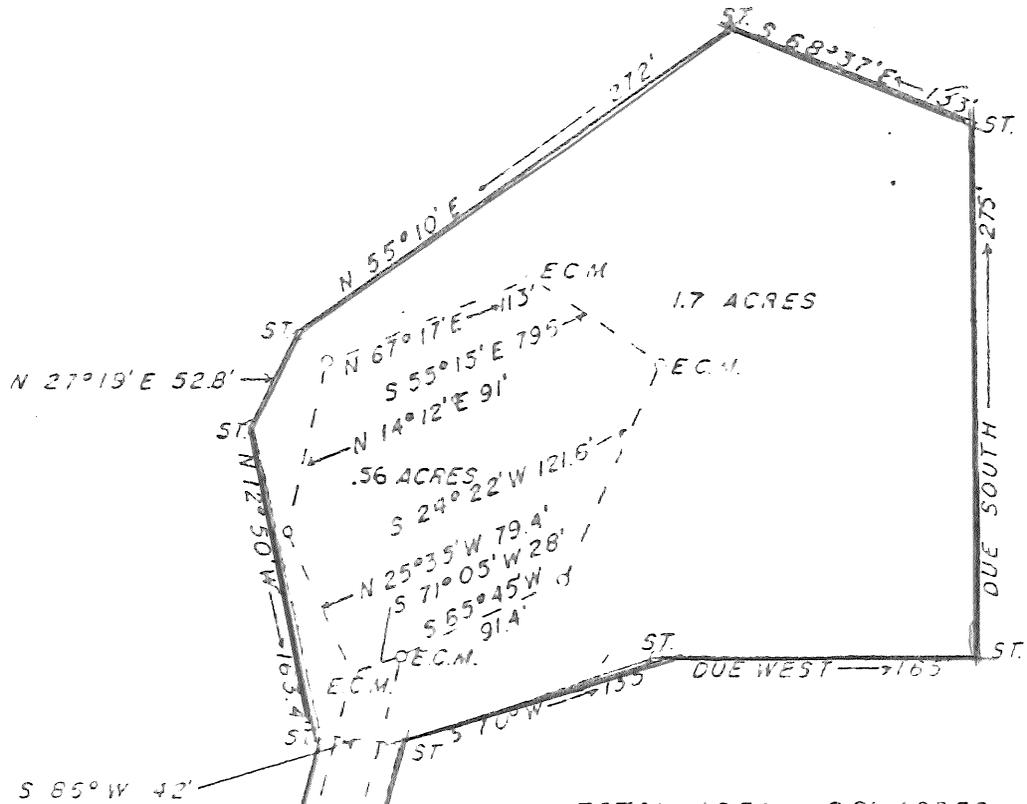
P L A T
 SHOWING PROPERTY OF
 EDWARD & MILDRED S. REGAN

TOTAL AREA = 2.91 ACRES INCLUDING PAT.

E.C.M. = EXISTING CEMENT MARKER
 E.I.P. = EXISTING IRON PIN
 ST. = STAKE

RICH SQUARE T.P., NORTH HAMPTON C.
 SCALE 1" = 100' — OCT. 8, 1979
 M. W. REVELLE & ASSOC'S.
 SURVEYORS
