NATIONAL REGISTER OF HISTORIC PLACES

Melton-Davis House

Bostic vicinity, Rutherford County, RF0323, Listed 8/29/2008
Nomination by Davyd Foard Hood
Photographs by E. U. Richey, August 2006

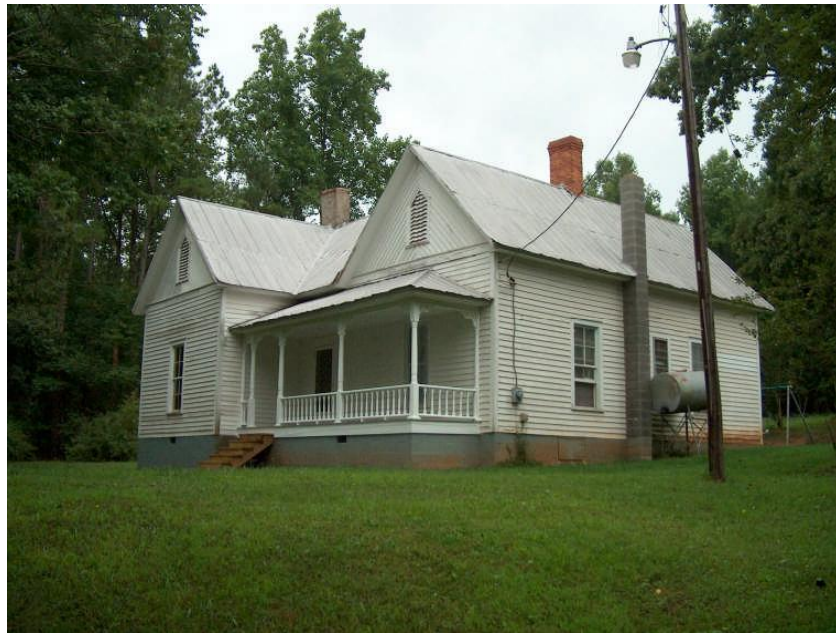
Overall view

The three-bay east façade of the Melton-Davis House is the most developed elevation of the residence. Here the south block, of the two uniform blocks that flank the center hall, projects toward DePriest Road by about six feet in front of the east wall of the hall and the north block. A one-story hip-roof porch extends across the central entrance bay and north block, stopping just short of the northeast corner of the house. It is supported by bracketed turned posts linked by a turned railing. The bracketed posts are original; however, the turned balusters in the railing are recent replacements that duplicate an original surviving half-baluster affixed to one of the posts. The deteriorated wood porch flooring was replaced as close as possible to in-kind. At the same time utilitarian wood steps were installed in front of the porch, on axis with the front door. The finish of the porch is typical of the period; however, it is the decorative treatment of the pedimented gable ends of the two parallel blocks that enhance the status of the house. Each triangular gable end is fitted with a centered, louvered wood vent whose pointed top echoes the pitch of the gable roof. The louver-boards have a decorative, scrolling front edge. The face of each gable is sheathed with flush boards placed on a diagonal and parallel with the rake of the roof. This simple example of complementing geometric harmony lends the house a particular distinction. A window is centered below each of these gables and they, in turn, flank the recessed center entrance. The front doorway retains its original glazed wood door with two long panes of glass in the upper half above the four-panel lower half.

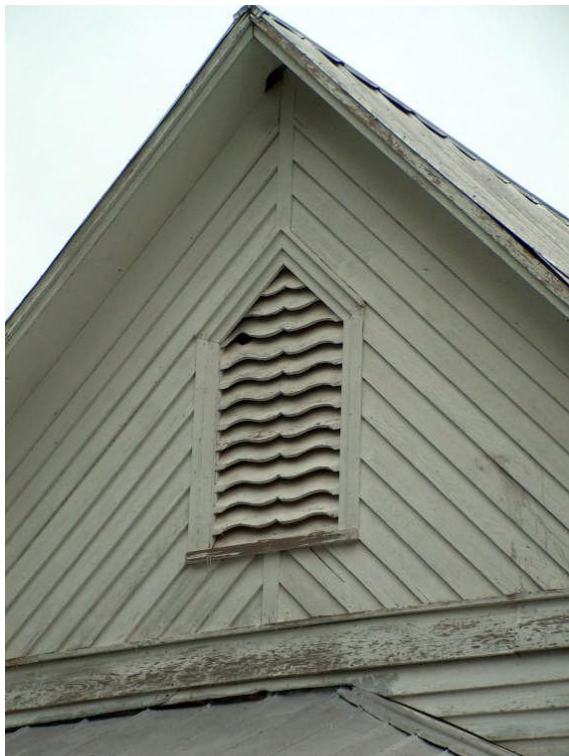
Gable decorative work – detail view
