NATIONAL REGISTER OF HISTORIC PLACES

Bostic Charge Parsonage

Bostic, Rutherford County, RF0596, Listed 8/28/2012

Nomination by Will Mueller and Caroline Donaldson

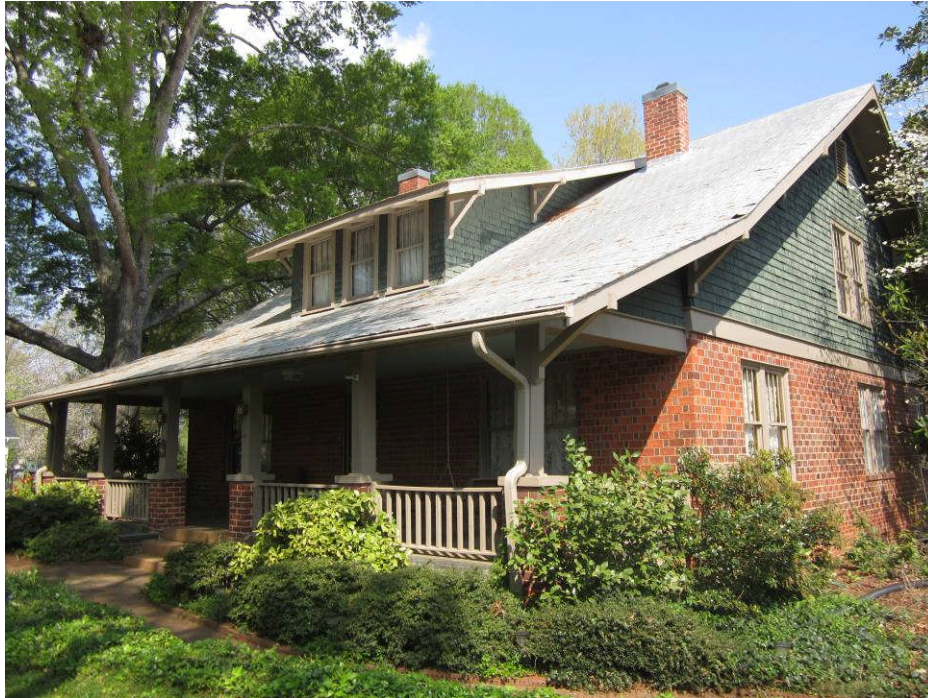
Overall view

The Bostic Charge Parsonage is a one-and-one-half-story, Craftsman-style bungalow. With the exception of the brick foundation, the first story is clad in wire-cut textured brick of many hues, from pale orange to almost black, laid in a Flemish bond-like pattern. Cedar shingles stained dark green cover the second half-story. The house is covered with a side-gabled pressed metal roof that extends to form a shed roof over a full-width front porch. The porch is supported by square porch posts on brick piers with wood balustrade with picket balusters. The front porch floor was replaced due to rot, and a balustrade with plain top and bottom rails and square balusters added between the piers. A shallow centered shed dormer features a trio of four-over-one sash, shingled sides and wood braces. The dormer is flanked by two interior chimneys at the ridgeline. Both chimneys are capped with aluminum, vented covers. The west chimney has a single course corbel at the top, and the east has a straight stack. A patch on the roof indicates that the interior kitchen chimney, which terminates at the underside of the roof in the attic, originally extended through the roof.

The three-bay (south) façade contains a centered four-light-over-two-panel front door identical to the two rear doors flanked by paired windows. Windows throughout are four-vertical-over-one sash with the original glass. All first-story windows rest on a brick sill and have plain wooden surrounds. The window layout of the three-bay, east and west elevations is identical, with paired windows lighting the front rooms (great room to the west, living room to

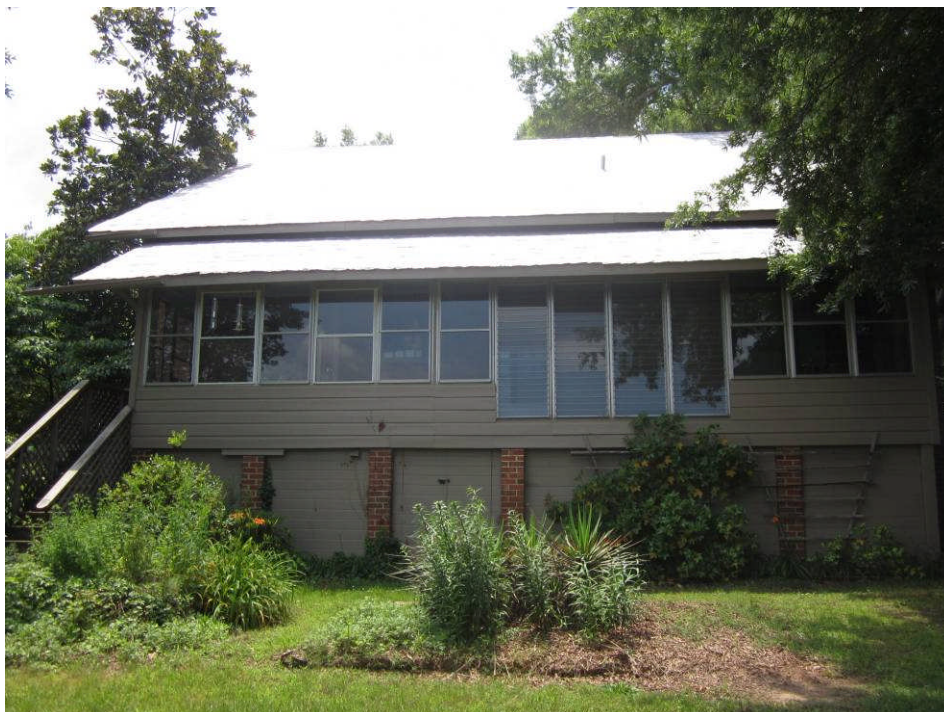
Rear view

The rear (north) wall of the main block contains two doors, one leading into the kitchen and the other to the central hallway. Here there are also three windows; one double-hung into the rear studio, and two four-light hopper-type which light the hall bathroom and laundry area of the kitchen. The rear elevation has an original sleeping porch supported by brick piers. Spaces between the piers are walled in with pressed-wood panels mimicking the ship-lap siding on the exterior walls of the sleeping porch above. Set in three feet from the corners of the house, the sleeping porch is thirty-six feet wide and six feet deep. Windows replace the original metal screening of the screen porch to allow use of the porch year-round. A wooden stair on the east end gives access to the porch from the rear yard. This stairway replaces the original stairs which were centered along the length of the porch. These steps were of cast concrete, four feet wide and supported on each end by solid concrete block walls, and had no railings. The porch roof is several inches below the main roof. Both roofs show exposed rafter rails.
