NATIONAL REGISTER OF HISTORIC PLACES

Thomas Bullard House

Hayne vicinity, Sampson County, SP0129, Listed 8/25/2014
Nomination by Laura A. W. Phillips
Photographs by Laura A. W. Phillips, June 2013

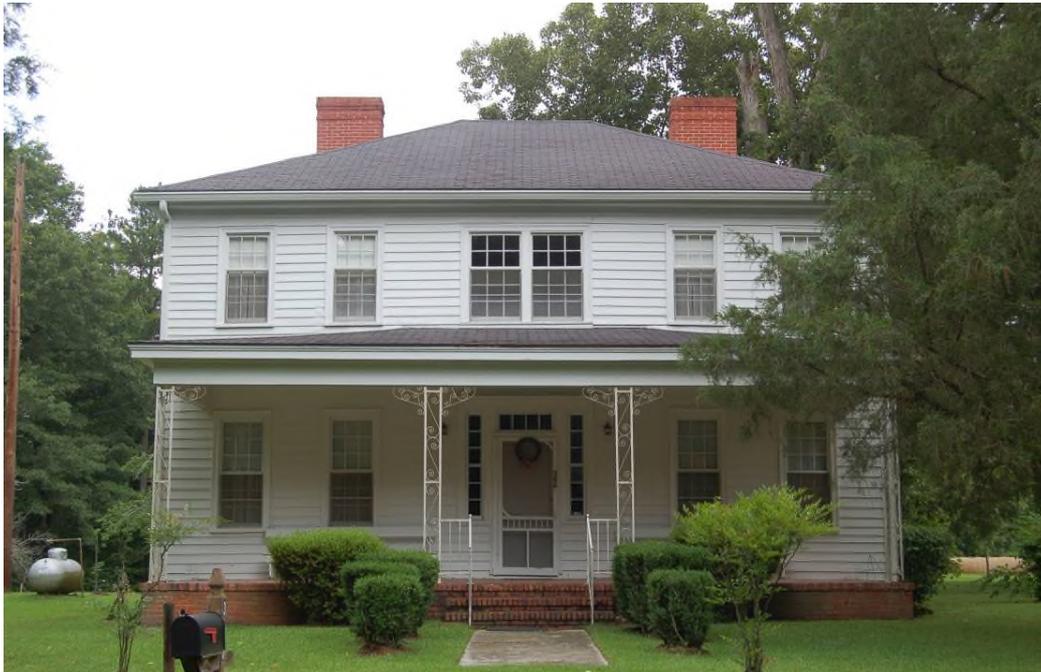
Façade view

The Thomas Bullard House is an 1856 Greek Revival-style dwelling with some interior features that reflect the earlier Federal style. Given its date of construction, the weatherboarded frame house is presumed to possess a heavy-timber mortise-and-tenon structural system, but this was not visible. The nearly square, double-pile house has a symmetrical five-bay façade, a brick foundation, an asphalt-shingled low hipped roof with boxed and molded eaves, and a pair of interior brick chimneys that rise between the front and rear rooms on either side of the house. The chimney stacks were rebuilt after Hurricane Hazel severely damaged the original ones in 1954. Extending northward from the rear of the two-story portion of the house is a one-story rear ell that houses a bathroom, dining room, and kitchen.

The main block of the house has nine-over-nine wooden sash windows on the first story and six-over-nine sash on the second story. All have simple two-part surrounds with an angled and mitered outer band and a narrow drip ledge. On the façade, a center-bay door originally opened to the upper level of the porch, but when the porch was replaced, the door was converted to a double window with a pair of six-over-nine sash. Each side elevation has four symmetrically placed windows on each story. Unlike the five-bay façade, the rear elevation is only three bays wide. It features a central door that is similar to the front door but has only five, instead of six panels – four vertical panels with a horizontal panel across the top. Above the door is a four-light transom. Another door, which has five horizontal panels, a three-light transom, and a plain surround, opens from the northwest room to the first-floor bathroom. The door probably replaced a window that was at this location before the bathroom was added. Above this door, the second-story window has been enclosed with weatherboards, because the roof of the added ell connector covered part of the opening.

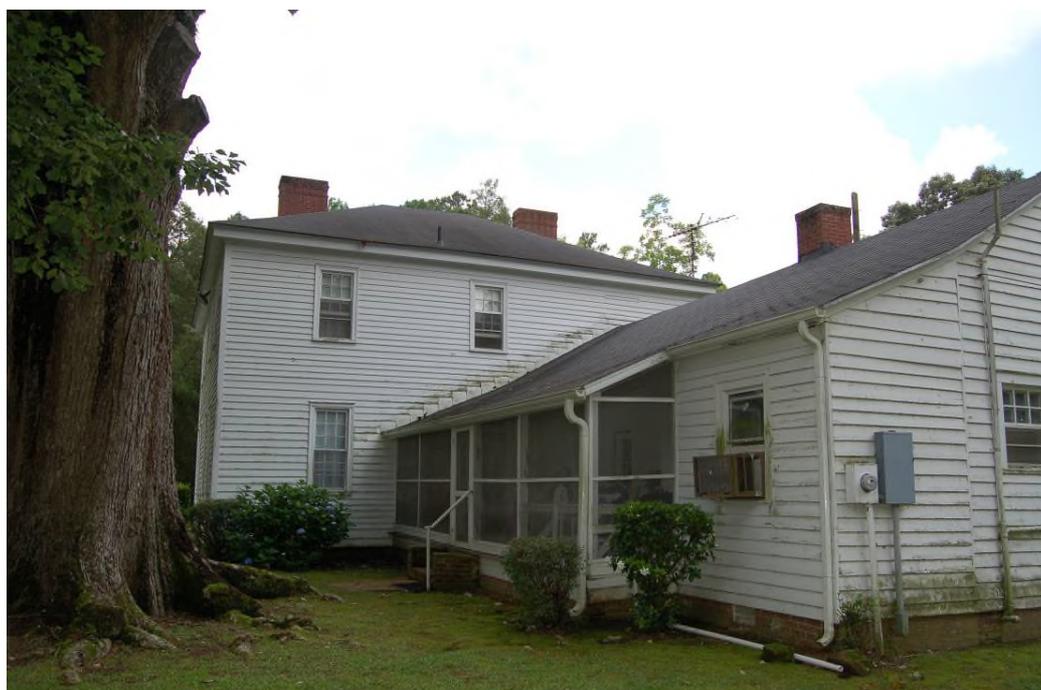
Rear view

A one-story ell projects from the west side of the rear of the house. It may be original, although its date of construction is not known. The ell has a gable roof with a central interior chimney rising through the roof ridge and a porch with a shed roof along the east side. Originally the ell was a separate structure containing the dining room and kitchen, as it does now. However, during the second quarter of the twentieth century, the space between the main body of the house and the ell was enclosed to create a bathroom.¹ The enclosure is sheathed with weatherboard siding, but the weatherboards are not aligned with those of the main house or the rest of the ell. The connector has a single six-over-six wooden sash window on the west elevation. North of the connector, the dining room has a six-over-six wooden sash window and, north of it, a six-light-over-three-horizontal-panel door on both west and east sides. The west side of the kitchen has a door that matches those of the dining room. The north end of the ell has

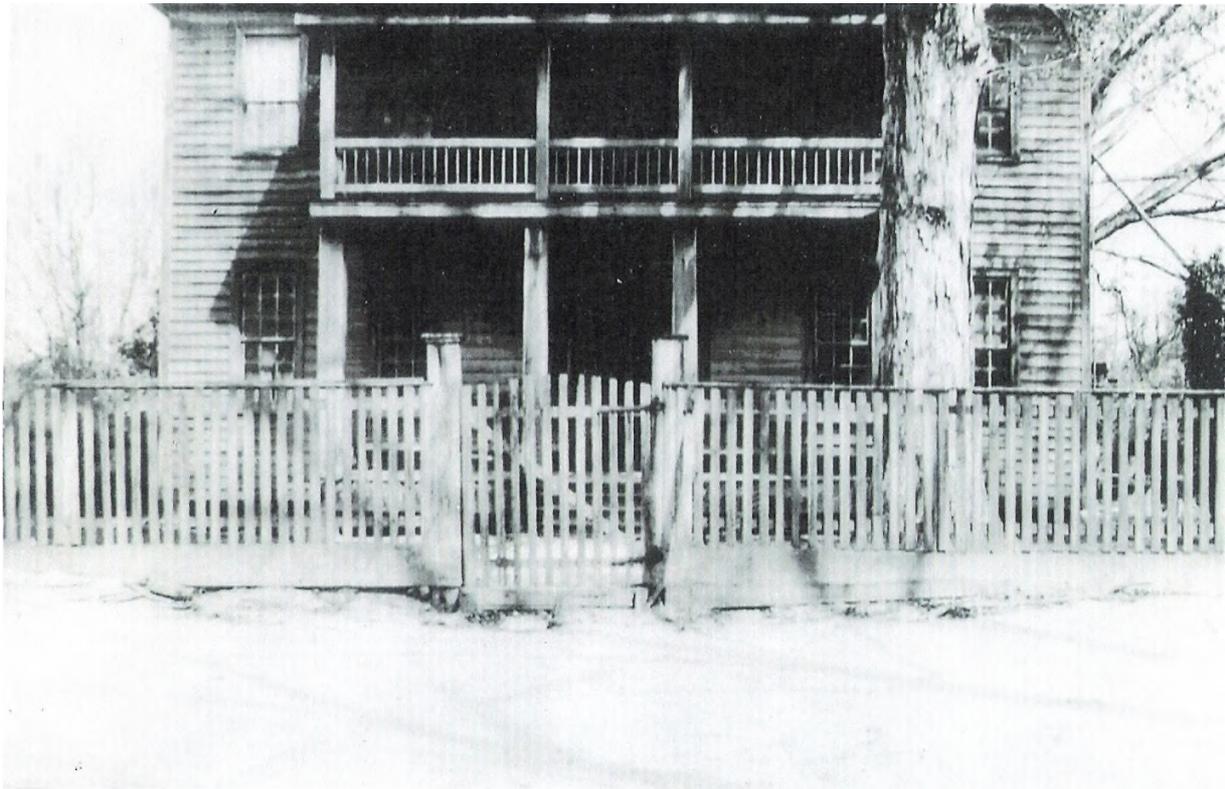
Section Number Documentary Photo Page 23

Documentary photograph of house, date unknown, with pre-Hurricane Hazel (1954) porch.
Courtesy of Margaret Sue Pahl Mills.

Hurricane Hazel destroyed the original front porch, and the present porch was built to replace it in the mid-to-late 1950s. What is presumed to be the original porch is seen in an undated documentary photograph of the house. It was three bays wide and had two tiers. The main level had four tapered-wood square posts with no balustrade, while the upper level had smaller, non-tapered, square posts and a plain balustrade. The porch roof cannot be seen in the photograph. The replacement, full-façade, one-story porch has a brick foundation and two brick
