NATIONAL REGISTER OF HISTORIC PLACES

Harmony Plantation

Wendell vicinity, Wake County, WA1926, Listed 1/29/2008
Nomination by Jennifer Martin
Photographs by Jennifer Martin, August 2006

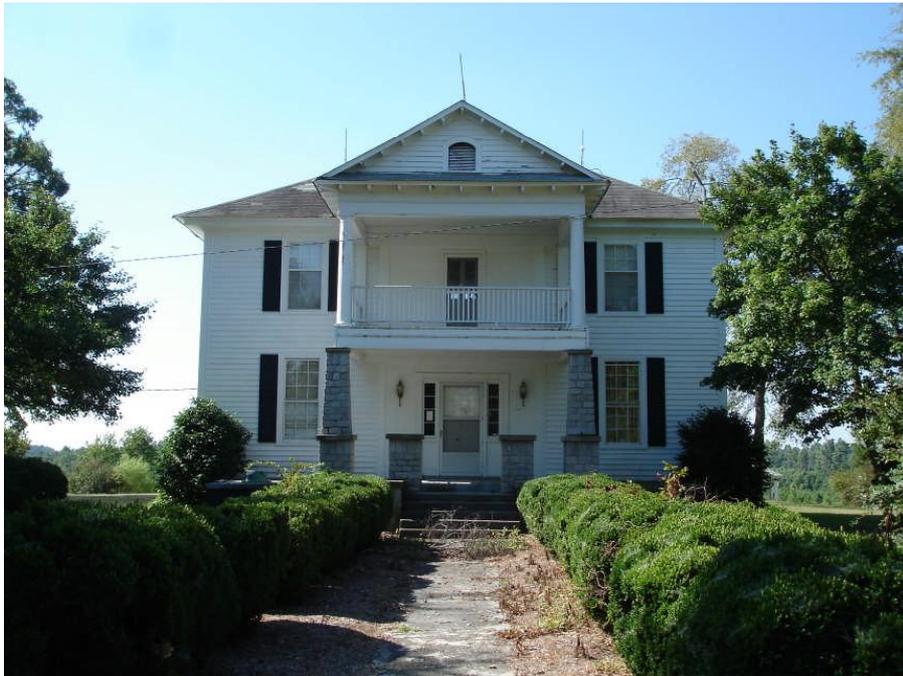
Façade view

The façade is a symmetrical composition with three bays on each level. Throughout the main block, windows on the first level are nine-over-nine, while the second level sash are a six-over-nine configuration. All the window and door surrounds on the main block display wide, heavy moldings typical of the Greek Revival style. A double-leaf, two-panel door centered on the first floor is flanked by sidelights and framed by a heavily molded surround with plain corner blocks. On the second level, the half-glazed door with two panels below the vertical windows is set in the same molding as the dwelling's main door, but without the corner blocks. On both levels of the portico, the doors are set in flush wood sheathing, a contrast to the weatherboard that covers the rest of the exterior. Simple pilasters frame the sheathing and likely indicate the position of the original portico.

The centered, double-tier pedimented, front-gabled portico with bracketed cornice features an arched-head gable vent centered in the tympanum. Unfluted Doric columns and square pilasters support the portico's upper level, while cut-granite battered posts atop cut-granite piers—an early twentieth-century replacement—are found at the outside corners of the portico's lower level; a concrete square tops each post, while a larger concrete divider separates each post from the pier. A pair of stone piers, each topped with a concrete square, flanks the stairs leading from the sidewalk to the portico. The first-level floor of the portico has been altered and is comprised of concrete blocks that have been painted black and topped with a slab of concrete. This porch floor, which was likely constructed in the early twentieth century, extends just beyond the windows and not to the full width of the façade. The concrete steps leading to the portico were likely installed when the porch floor was altered.

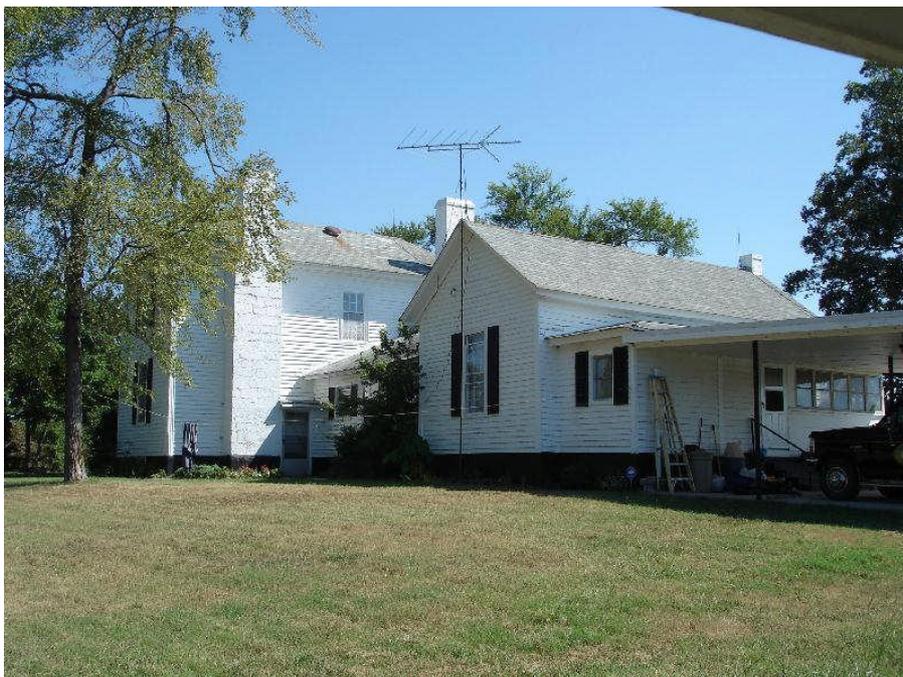
Side and Rear view

The east elevation displays the three sections of the house: the main block, the rear ell, and a side-gabled rear block. This side features the same window configuration seen on the façade, but with one bay. The rear ell displays a nine-over-nine sash on the north end and a shed-roofed projection on the south end that corresponds to the location of a bathroom that was added in the mid-twentieth century by Lee W. Jones. The east elevation of the rear block displays a gable end with a slender brick stack that was originally used as a cooking flue. Small one-over-one sash windows are positioned on each side of the flue. The rear block, with its molded corner posts and west-facing nine-over-nine window, likely dates to 1833 and has the appearance of an originally detached kitchen building that has been moved and joined to the house. The Lee W. Jones family tradition holds that this block was built at its current location in 1833 and has always been joined to the house.

The rear elevation consists of a 1970s hipped-roofed addition to the rear block. The eastern half is sheathed in synthetic siding and features a row of metal-framed one-over-one sash and an aluminum door. Weatherboard covers the western half of the rear addition and a small one-over-one window pierces the west elevation. A flat-roofed carport with round metal supports extends from the rear elevation and shelters a poured-concrete parking pad.
