**NATIONAL REGISTER OF HISTORIC PLACES**

**First Baptist Church**

High Point, Guilford County, GF0550, Listed 1/8/2009  
Nomination by Beth Keane  
Photographs by Beth Keane, October 2006 and July 2007

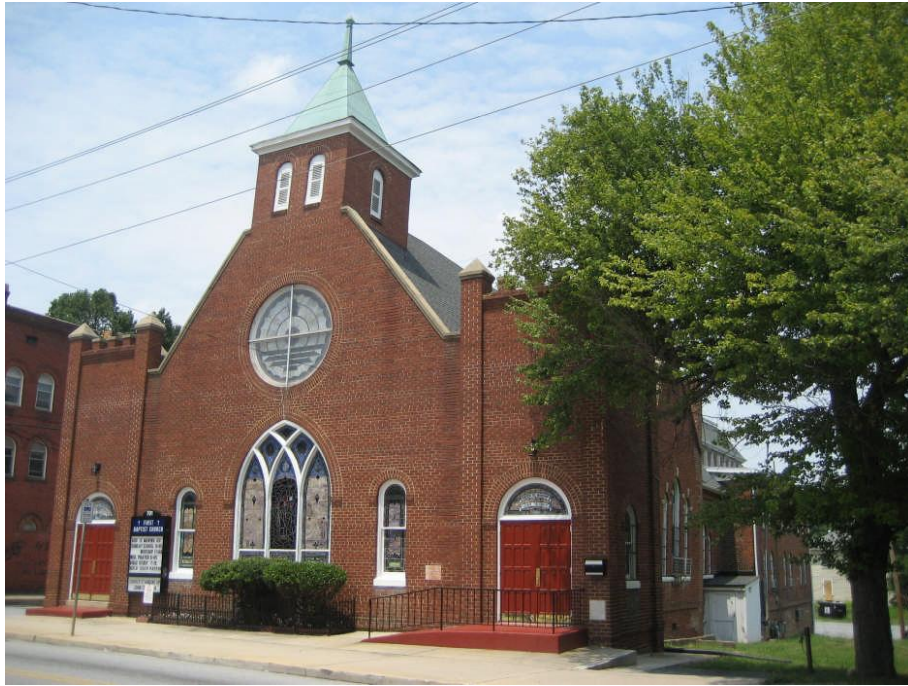
Overall front view

The appearance of the church's façade can be attributed primarily to the building's expansion and renovation in the early 1950s. The primary entrances to the church are through eight-foot-high, multi-paneled, double wood doors set in wood frames located on the front elevation of the corner towers. Each door opens into a square vestibule. Above each door is a round-arched, stained-glass transom in a molded wood frame, surmounted by three rows of header bricks. Each window includes the following inscription: "Enter to Worship, Leave to Serve." An iron electric lantern hangs above each door. Both entrances are close to grade. Installed within the last fifty years, a small concrete handicapped access ramp flanked by a wrought-iron railing rises from the west to lead to the east-side door. A brick water table runs along the west, north, and east walls of the church and the rear annex.

The four corners of the crenellated towers project and have pyramidal cast-stone caps, while the tower merlons and the rakes of the central gable have molded cast-stone coping. In between the two towers, the tall gabled façade features a large, triple-lancet, stained-glass window with Y-tracery in a single pointed-arched opening. Flanking this window on either side are slender round-arched, stained-glass windows. The 1908 rose window removed from the original façade is centered over the pointed-arch window, mostly in the gable. The high, steeply-pitched gable roof is interrupted at the apex of its southern end by a short, square-in-section brick bell tower with a wood cornice surmounted by a short pyramidal copper spire sheathed in copper and topped by a pinnacle with a finial. The belfry is flush with the main façade and features two slender round-arched vents with brick sills on the front, as well as one on each of the east and west sides. In 2005, a new roof of composite shingles replaced a previous shingle roof.

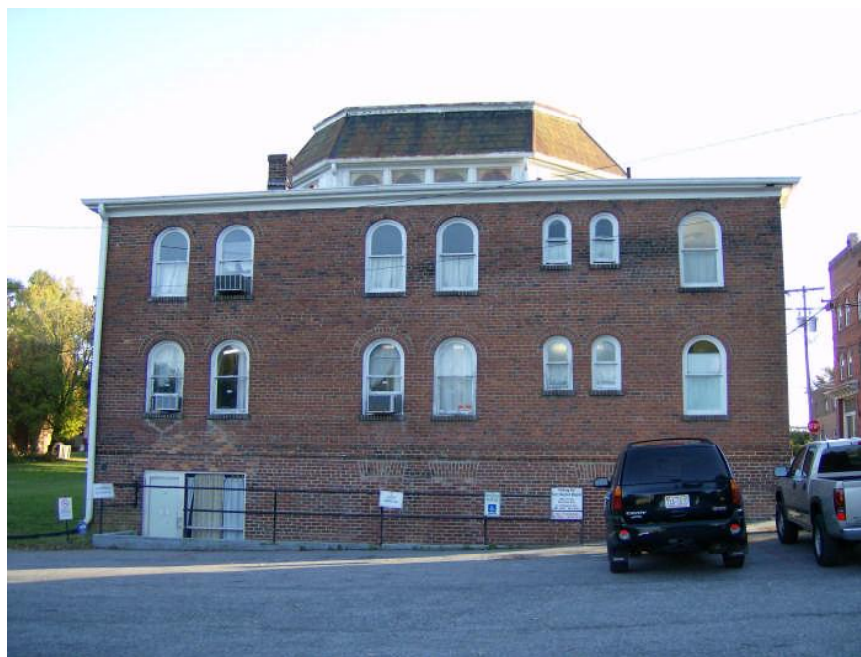
Rear view

A large square two-story brick annex was added to the north side of the church in 1916. Built on a slope, the annex has a raised basement delineated by a corbelled brick water table. The annex features a flat roof with a wide wood cornice, wide overhanging eaves, and a central hexagonal clerestory with circular, frosted windows within square frames and a mansard-like roof. The remaining windows in the annex are mostly paired, round-arched, one-over-one, double-hung sash, set in wood frames with brick sills, and topped by two rows of header bricks. The main entrance into the annex is centrally located on the west side (Hobson Street) and is
