NATIONAL REGISTER OF HISTORIC PLACES

Marshall Main Street Historic District

Marshall, Madison County, MD0056, Listed 8/16/2007
Nomination by Sybil Argintar
Photographs by Sybil Argintar, July 2006

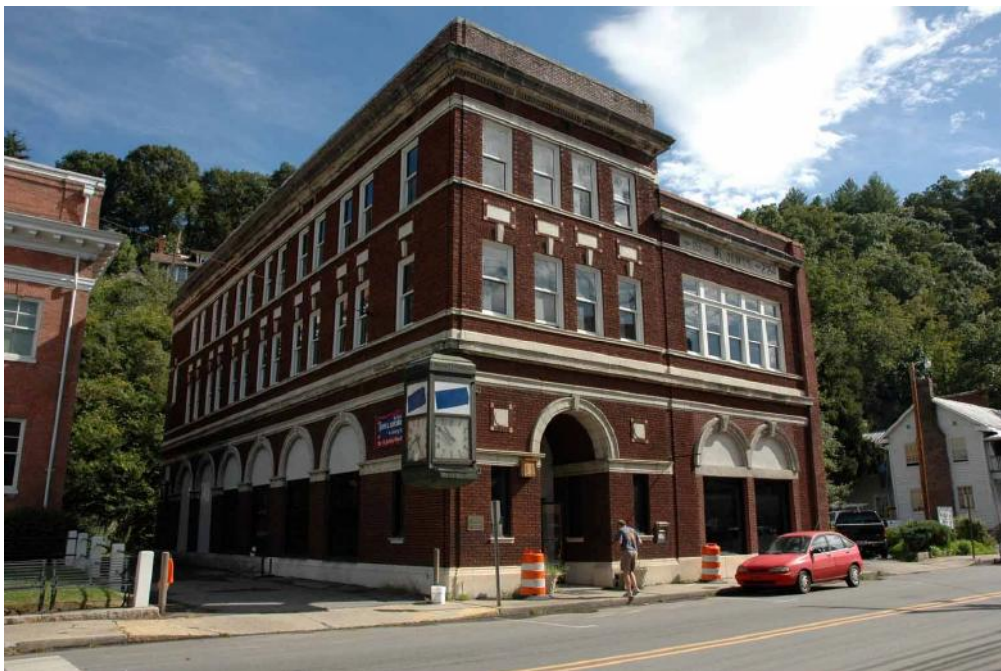
Bank of French Broad, 100 Main Street
