NATIONAL REGISTER OF HISTORIC PLACES

Grier-Rea House

Charlotte, Mecklenburg County, MK2698, Listed 8/30/2010
Nomination by Mattson, Alexander and Associates
Photographs by Mattson, Alexander and Associates, December 2008

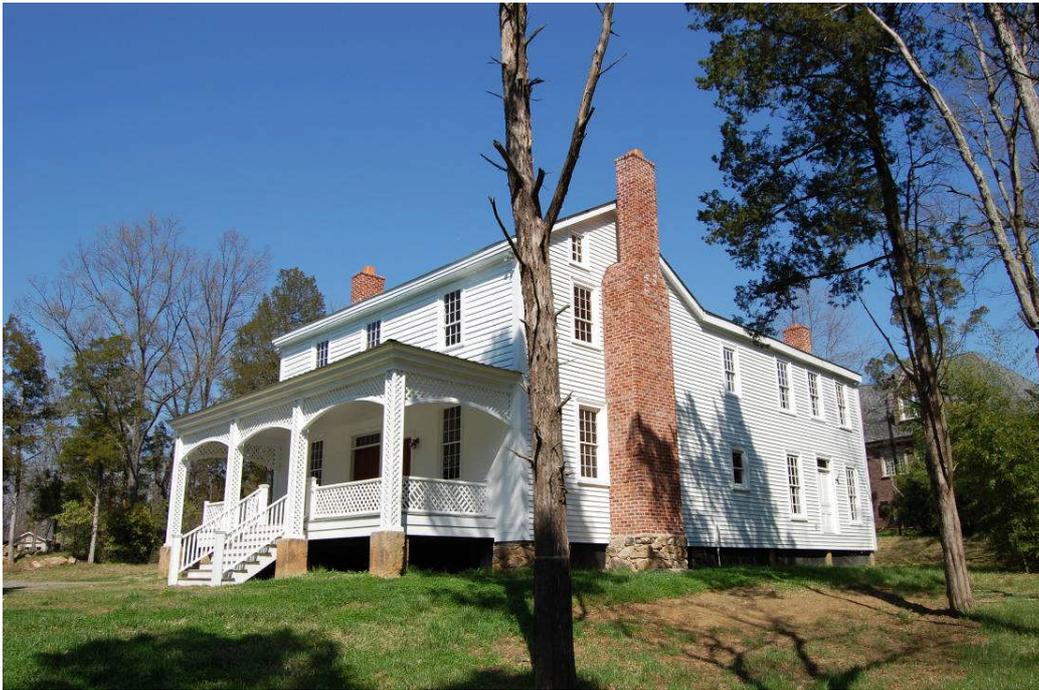
Overall view

Facing west, the house consists of a two-story, single-pile, side-gable main block and a full height rear wing that is flush with the south wall of the main block. The side-gable roof replicates the original roof in its pitch and simple, boxed cornices across the façade and rear elevation. The new, boxed eaves at the gable ends are slightly deeper than the original, flush eaves. The roof is covered in asphalt shingles. The house rests on a modern concrete foundation faced with original fieldstone at the corners to suggest the original fieldstone foundation piers. The façade includes original flushboard siding on the first floor under the shelter of the front porch and original

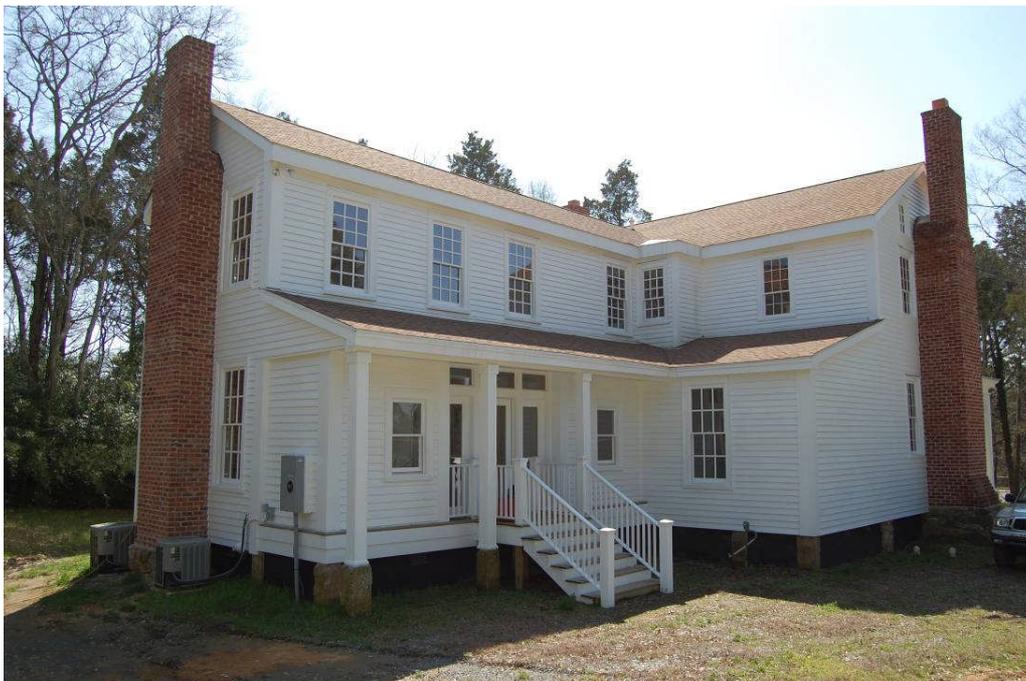
Rear view

The wing's rear elevation has a brick chimney flanked by six-over-six windows on each story. The north elevation of the wing has replacement, nine-over-nine windows with replacement surrounds on both the first and second stories. Probably during the mid-twentieth century, the four second-story windows on this elevation were removed and covered with weatherboarding. The original window frames survived underneath. The shed-roofed porch replicates the original, and the original, square, wooden porch posts with simple caps and stone piers remain. As with the front porch, the porch roof on the ell extends beyond the porch floor. Modern porch steps lead to the modern rear entrance that replaced the original doorway and two-light transom. This entry now consists of a glazed door with sidelights and a three-part transom. The entrance is flanked by modern, enclosed end bays with one-over-one windows.
