NATIONAL REGISTER OF HISTORIC PLACES

Davenport House

Creswell vicinity, Washington County, WH0465, Listed 9/5/2007
Nomination by Nancy Van Dolsen
Photographs by Nancy Van Dolsen, April 2006

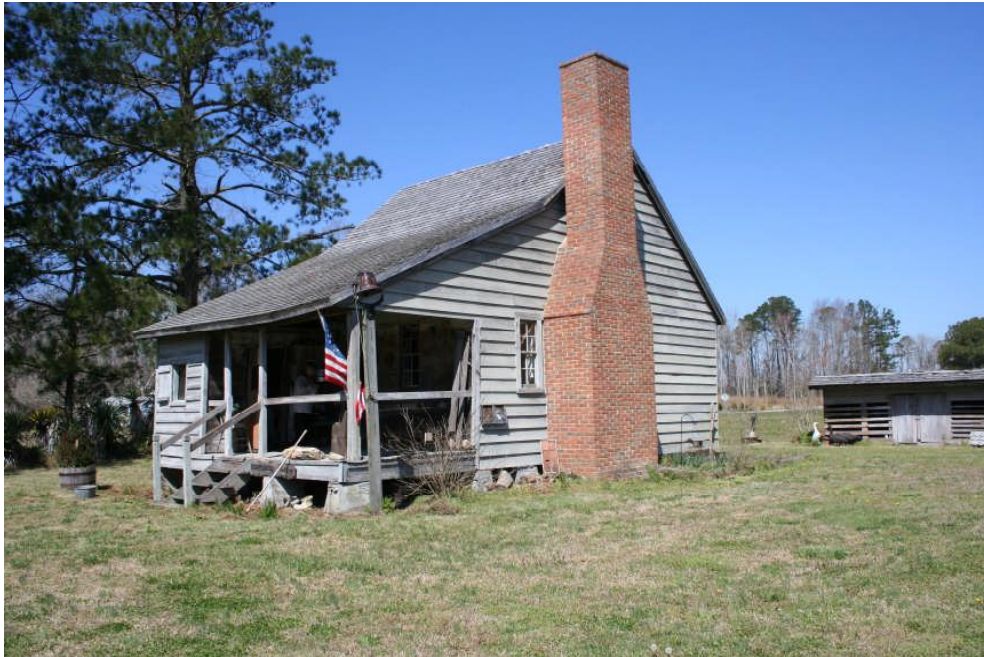
Front and side view

The Davenport House, constructed ca. 1815, is a one-and-a-half story, heavy timber frame house with a rear shed room incorporated under the main side-gable-roof. A broken-pitch roof on the façade shelters the engaged porch. This house form is often called a coastal cottage in North Carolina. The heavy timber frame has hewn studs and down corner braces which are mortised, tenoned, and pinned into the corner posts. The west end bay of the porch has been enclosed, most likely during the late nineteenth century. It has simple vertical stud construction.

The three-bay house sits on trapezoidal wood cypress blocks, which are narrower where they come in contact with the sill. The floor joists are hewn on all four sides, and are lapped over the sills. The house is sheathed in weatherboards, with the exception of the area under the porch which is flush-sheathed. Due to advanced weathering, the weatherboards on the east and west elevations were replaced during the late 1990s restoration of the building by the Historical Society of Washington County for its use as a museum. The exterior end chimney on the east elevation was also constructed at that time; it replaced a concrete block chimney which had been constructed in the mid-1950s after a hurricane had destroyed the original chimney. The wood shingle roof also dates to the late 1990s.

The engaged porch roof rests on simple tapered posts with chamfered corners. A simple beaded handrail runs between the posts. The enclosed room at the end of the porch (called the piazza room) has a small opening with a wood shutter on the south elevation, and a board door with three battens leading from the porch into the room. A four-over-four sash window is located east of the front door, which is a three board door with three battens nailed and clinched to the side facing the interior and a wood box lock.

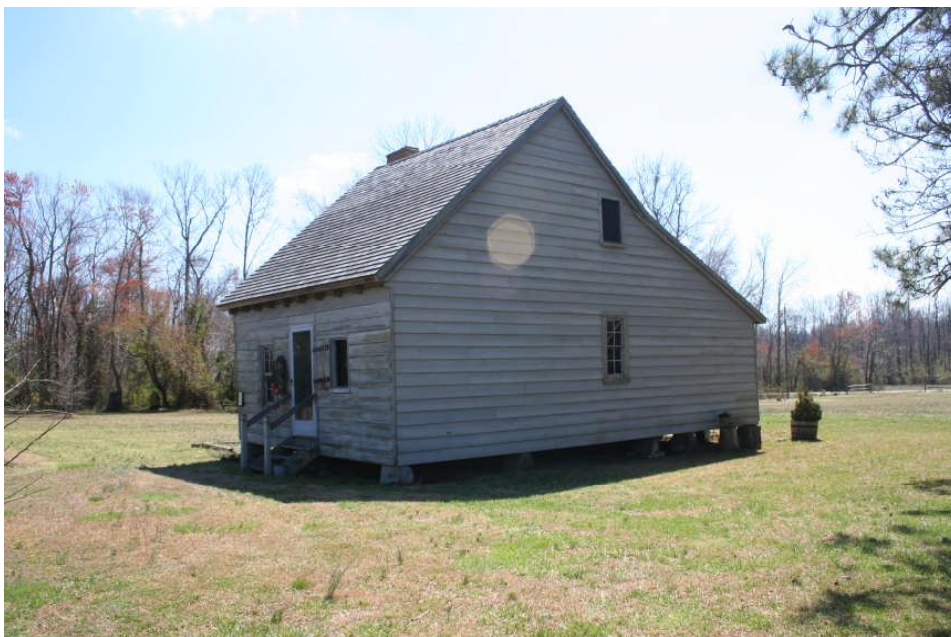
Rear and side view

The west elevation has one four-over-four sash window on the first floor and a shuttered window in the attic level. The rear elevation features a central door flanked by a window with only a battened shutter on the west side and a four-over-four sash window on the east side. A modern door protects the original board door on the rear elevation that has only a latch string for security.

The east elevation has the reconstructed brick chimney with a shuttered opening in the attic and two four-over-four light sash windows flanking the chimney. The reconstructed chimney features an all-stretcher bond and a single shoulder.
