NATIONAL REGISTER OF HISTORIC PLACES

Benjamin Hubbard House

Moravian Falls vicinity, Wilkes County, WK0213, Listed 1/29/2009

Nomination by Mike Hubbard

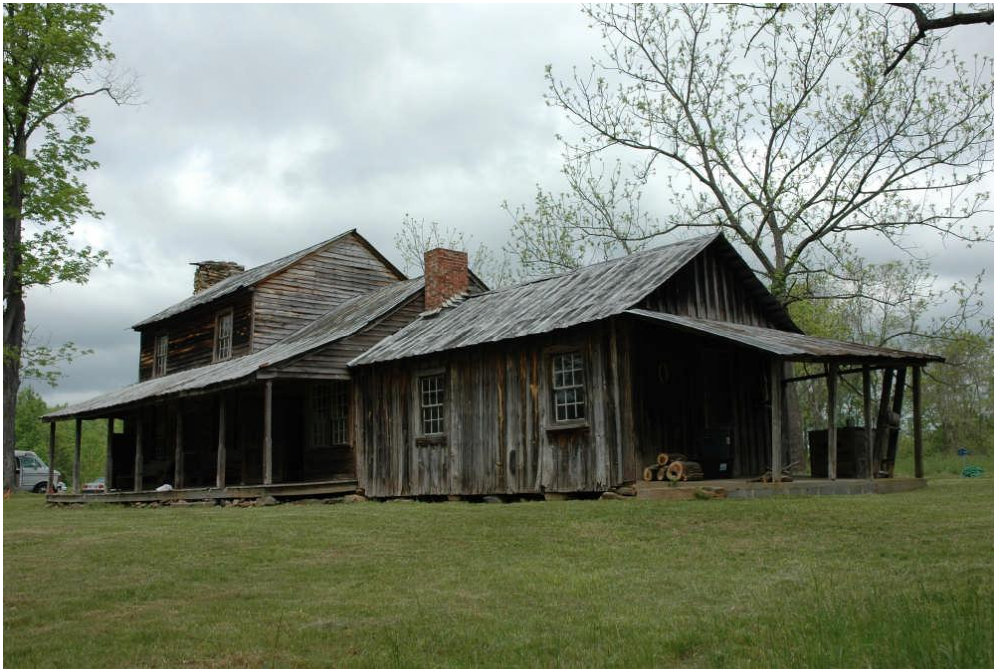
Overall front view of house

The Benjamin Hubbard House is a 1778 side-gabled log house with frame additions made to the east of the main block on two occasions, the first likely taking place in the 1790s and the second in ca. 1870. The house is located a mile and a half west of Moravian Falls and within fifty feet of the abandoned Old Burke Road to the south, which runs parallel to the current Highway 18. Seven miles to the east is Wilkesboro, the Wilkes County seat. The property is twenty-two acres of rolling terrain with Gin Branch running west to east through the property. The front porch faces due south and affords a view of the Brushy Mountain range. Behind the house, on the north side, are wooded ravines, pasture and crop areas, typical of late eighteenth century farmsteads in the foothills of the Yadkin River Valley. A large black walnut tree dominates the east side of the house, while two smaller walnuts are along the rear. A large hickory tree is on the west side of the house. Located to the northeast, 236 feet from the rear of the house, is a two-story, banked log barn, dating to 1846. The barn features covered, cantilevered logs on three sides allowing extra hay storage capacity under an extended roof. The house and barn are both in excellent condition.

The original two-story, hall and parlor plan log house, built in early 1778, was the home of John Dyer and later acquired by Benjamin Hubbard in 1784. The floor plan is original and intact. The facade of the log portion has a centered door with single nine-over-six windows on either side, as well as two second-story six-over-six windows above a shed-roof porch, which runs the length of the original log structure. Accessed from the far west side of the porch is a small windowless saddle room, outside the main core of the house and abutting the massive, central single-shouldered fieldstone chimney on the west elevation. Weatherboard siding covers the building to the south side of the chimney, whereas to the north side of the chimney, the building is covered with board and batten siding. The rear (north) elevation has one lower and one upper-level nine-

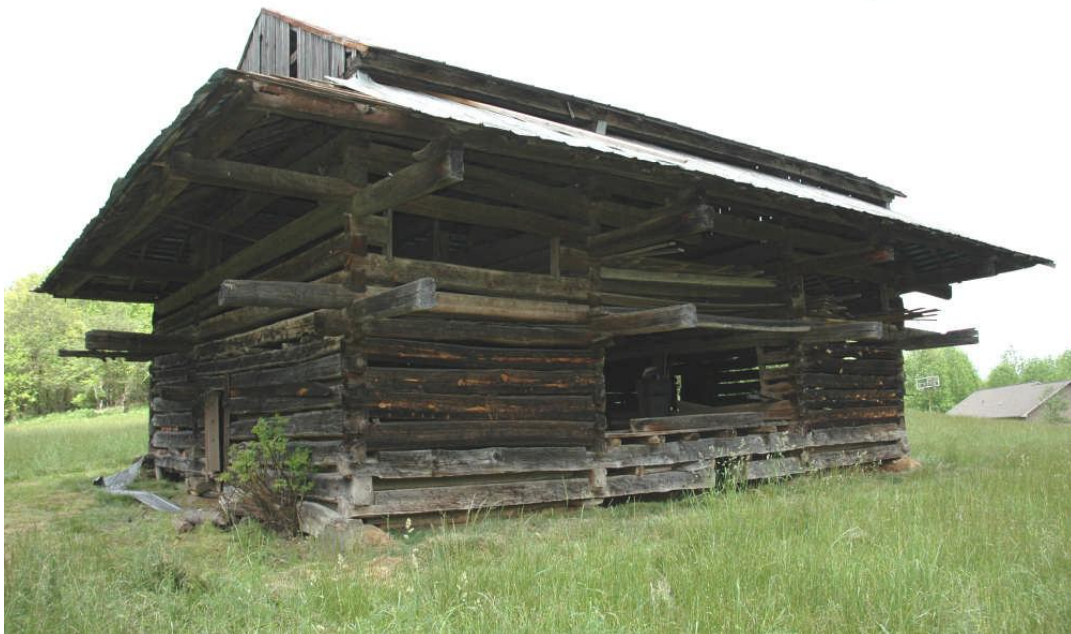
Barn

The two-story barn was constructed in 1846, and with an unusual combination of design features, appears to be a hybrid of traditional barn forms. The structure possesses a cantilevered roof and multi-pen floorplan similar to other barns in the mountains of western North Carolina and east Tennessee, though different in proportion and roof form. Its form is also reminiscent of the cantilevered bank barns of the Mid-Atlantic States.

The exterior dimensions of the structure are roughly thirty feet wide by thirty-five feet deep, with the rear (north) side banked into a gentle slope. The structure of the barn is composed of two log pens, approximately eleven feet wide by thirty-five feet in length, with a thirteen feet wide runway in between. The rear (north) end of the runway opens into an embankment, while the front (south) end sits three to four feet above ground level. A log wall (transverse to the runway) divides the barn interior into six areas, four stables on the ground floor and two storage lofts on the upper floor. This dividing wall also marks a transition in the roof structure. A side-gabled roof sits atop the lofts and runway, while a shed roof covers the rear stables. The roofing system consists of skinned wood rafter poles mortised and pegged at the ridge and plate. Original roofing materials were likely wood shakes or shingles, though the roof and rear wall are now sheathed in 5-V metal roofing.
